Indicator Test Report for SpotSee

P-23-026

August 22, 2023

MxV Rail

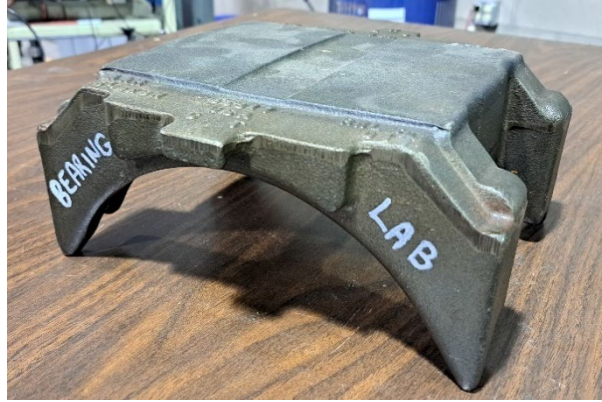
Figure 2. Bearing adapter

The bearing adapter makes contact with the cup and, therefore, the adapter could have the same temperature as the bearing. At this stage in testing, it is important to ensure the indicator strips will adhere to and survive on any surface chosen for operations. One advantage of placing the indicator strip on the bearing adapter is that, because the adapter is stationary, the indicator strip will remain visible 1) during walk-by visual inspections or 2) to wayside detectors. Figure 2 shows the bearing adapter.

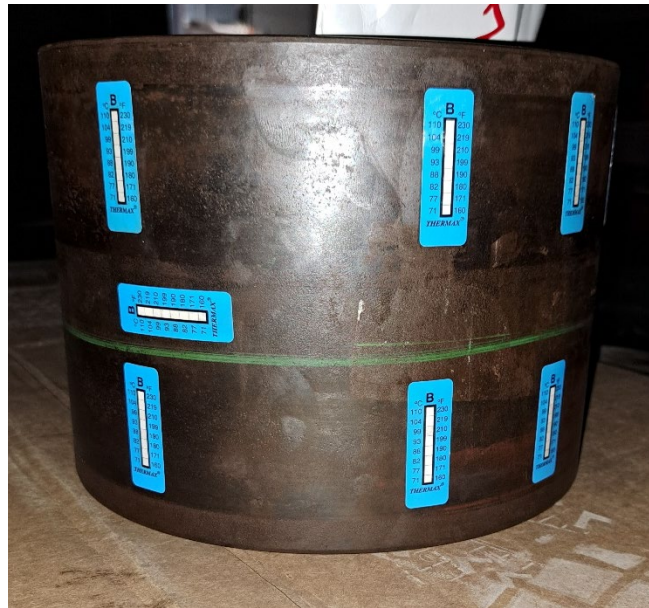
Figure 3. Bearing cup with indicator strips

Thirty indicator strips were used during testing. Twenty indicator strips were placed on the bearing cup, and ten indicator strips were placed on the bearing adapter. These indicator strips were placed in the areas most likely to experience temperature variations during operations. The bearing cup and bearing adapter surfaces were cleaned with degreasing soap and dried before the indicator strips were applied. The indicator strips were placed against the surface of both the bearing cup and the bearing adapter and pressed in place by hand to ensure complete contact. Figures 3 and 4 show the indicator strip placements.

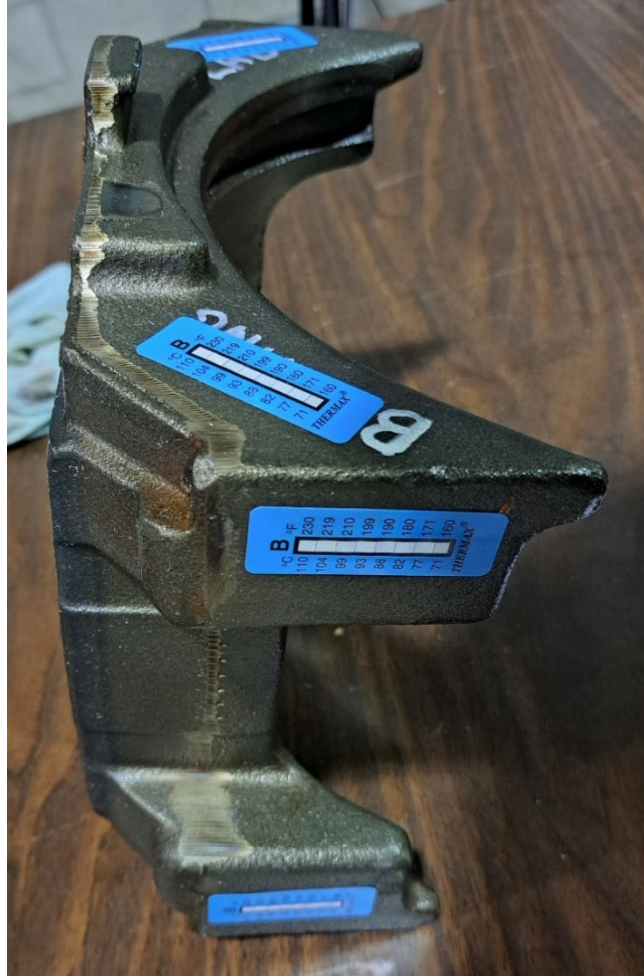
Figure 4. Bearing adapter with indicator strips

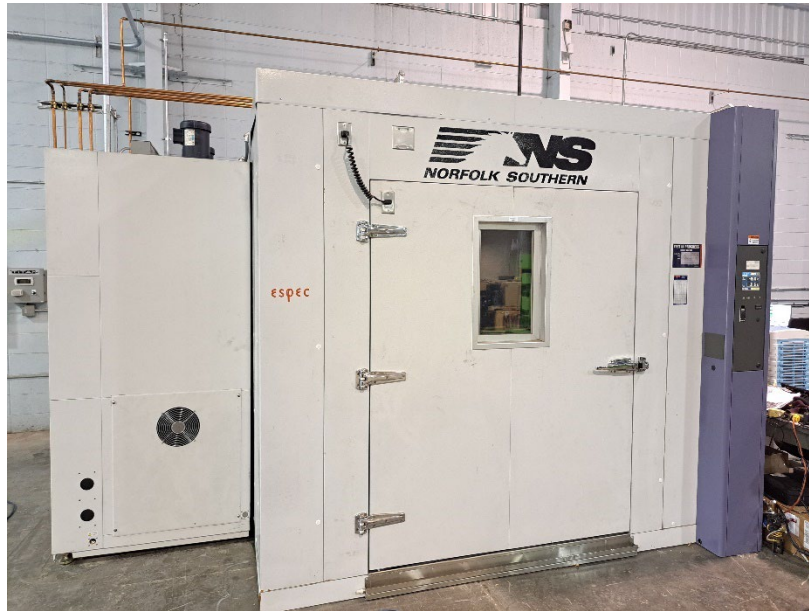
Figure 5. Environmental chamber

MxV Rail used an environmental chamber during the durability tests (see Figure 5). The sealed chamber is temperature and humidity controlled. For the testing, the relative humidity in the chamber was set at a higher temperature (92°F).

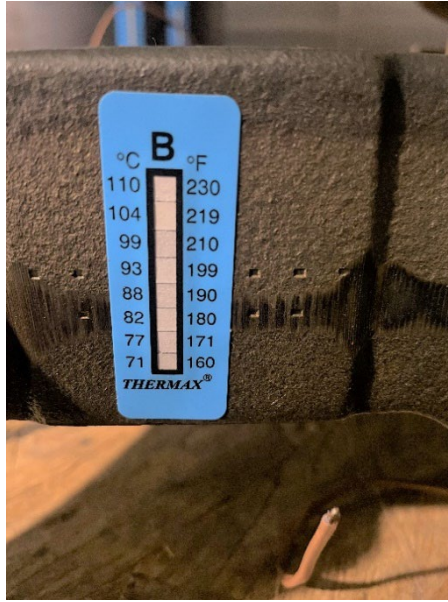
Figure 6. Bearing adapter after 60 temperature cycles

There was no noticeable change in the adhesiveness or readability of the indicator strips between the time the indicator strips were affixed and the time the 60-cycle test was concluded. There was no need to clean the indicator strips after the test (see Figures 6 and 7). All the indicator strips were removed from both the bearing cup and the adapter to be returned to SpotSee for further evaluation. Due to the adhesion of the indicator strip to the bearing cup and its smooth surface, a razor blade was needed to pry the indicator strip from the bearing cup. Due to the rougher surface of the adapter, the indicator strips were removed more easily from the adapter, and a razor was only needed to pry up a corner of the indicator strip before it could be pulled off.

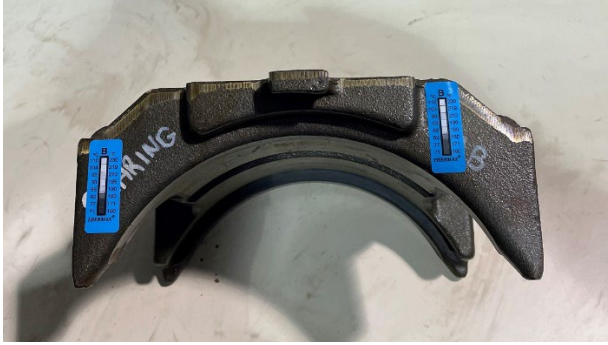
Figure 8. Readability of bearing adapter after reaching 180°F (View 1)

Upon completion of the cyclic test, the environmental chamber was heated to 180°F. After the test bearing cup and adapter reached 180°F, the test was concluded, and the chamber was allowed to cool to the ambient temperature of the test facility before the test bearing cup and adapter were removed from the chamber and visually examined. The examination found that all the indicator strips were firmly attached to the steel parts, and the indicator strips could be clearly read. At the end of the high temperature test, the indicator strips on both the bearing cup and the adapter showed the peak temperature of 180°F (see Figures 8, 9, 10, 11, and 12).

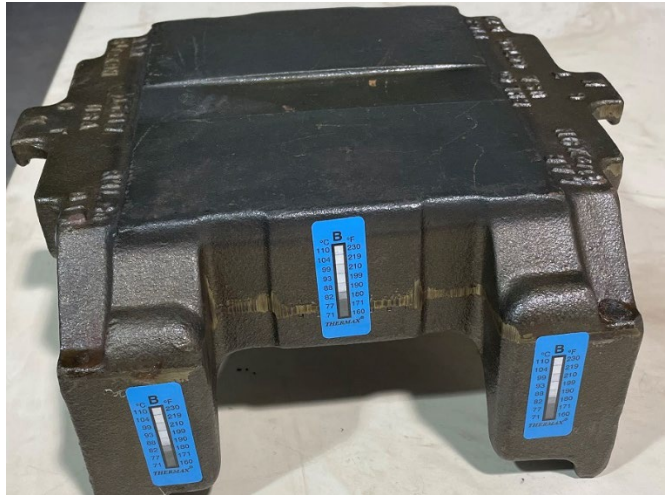
Figure 9. Readability of bearing adapter after reaching 180°F (View 2)

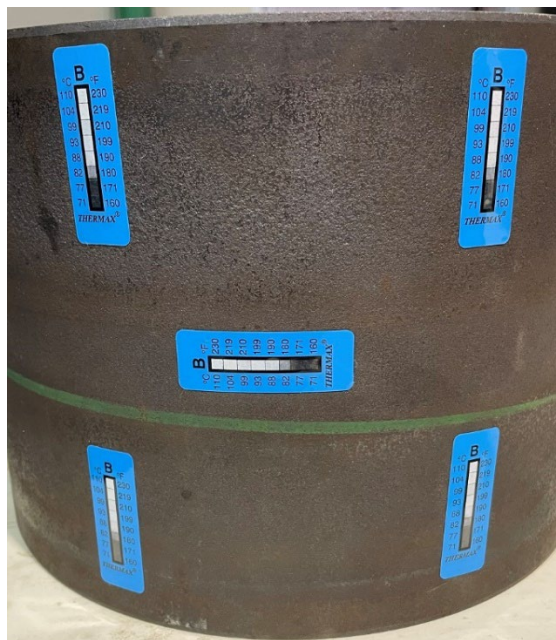
Figure 10. Bearing cup after reaching 180°F (View 1)

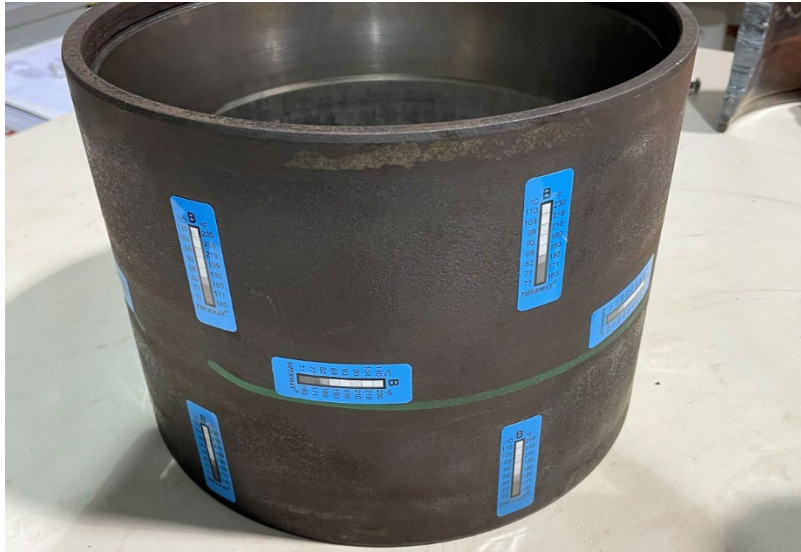
Figure 11. Bearing cup after reaching 180°F (View 2)

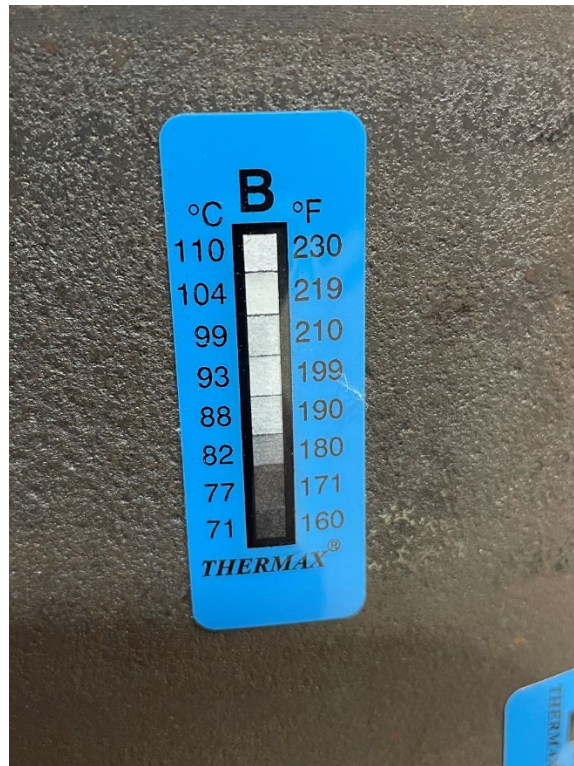
Figure 12. Indicator after reaching 180°F
